Importance of Venting in Injection Molding

Pandiarajaguru

Newell Brands

Example of Venting issue :

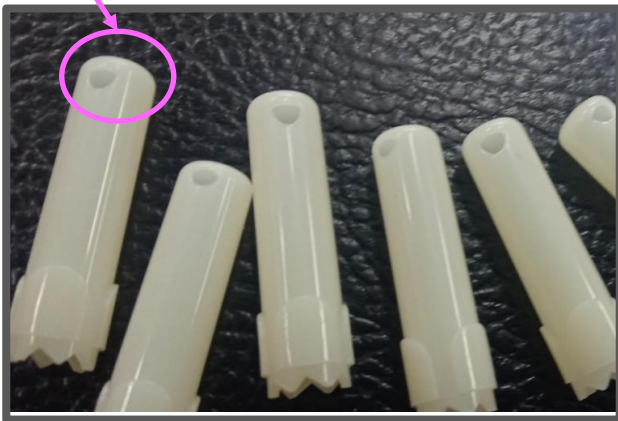
- Difficulties in molding the parts due to airtrap
- Short filling is noticed in all 64 cavities
- A hole is formed at the top of the plunger due to airtrap which aesthetically affects the quality and makes this component unusable
- On looking the samples closer, there were flow marks too
- Short fill noticed in all the 64 cavities are at the same place

Hole due to Air trap

- Airtrap or Gas trap formed during filling phase has resulted in Short fill
- Gate location is near the core side & hence the cavity side is expected to fill at last. Airtrap is expected at the last filling area.
- Lack of venting in the cavities. **Venting is not provided in the mold initially in the last filling areas**

- To relieve the air trap or gas trap, it was recommended to provide venting at the top of the plunger where the hole is formed
- Cavity was split into two pieces. Two piece cavity insert concept used.
- Gas vent clearance to be provided in the tool

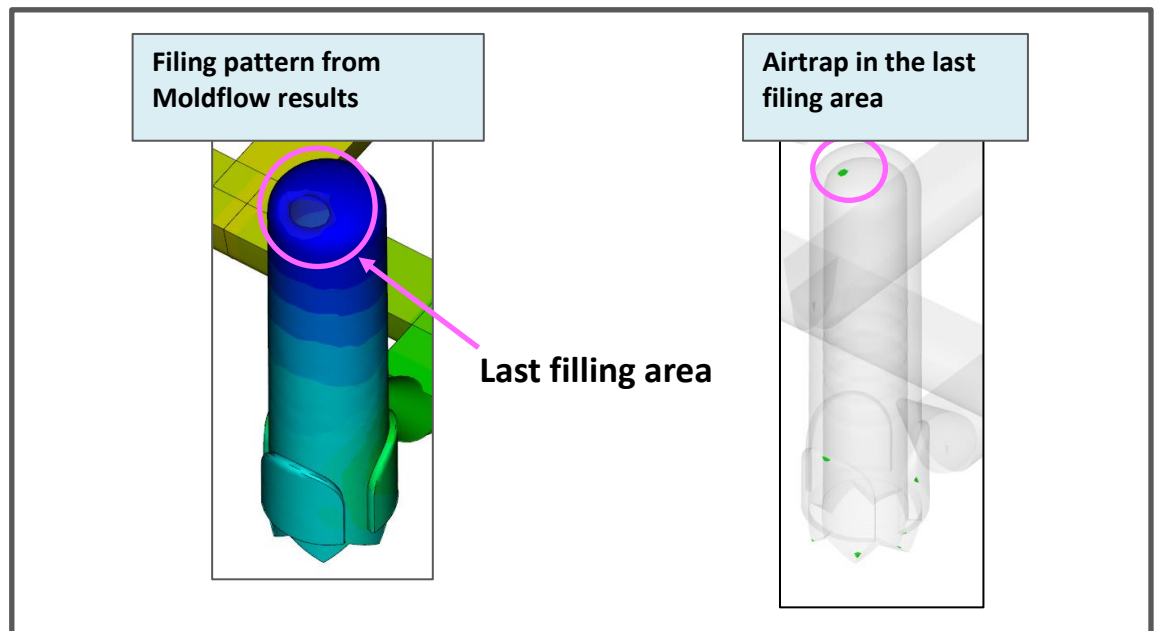
Filling pattern and Airtrap

- As the gate location is near the core side, the last filling area is expected to be in the cavity side.
- The melt started to flow from the gate orifice near the petal area of the plunger, slowly filled the shroud area and the last filling area was expected to be the top of the plunger (opposite to the gating side). The air present in the cavity was pushed by the converging polymer flow front; Hence there was no venting provided to relieve the gas from the cavity, the air or gas could not escape and got trapped to form a hole or short shot in the part

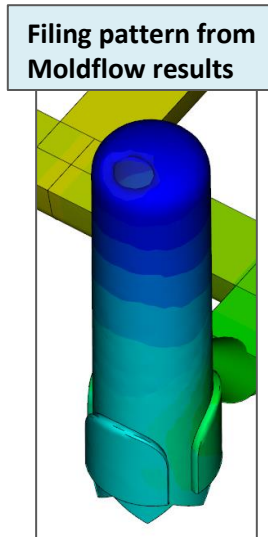
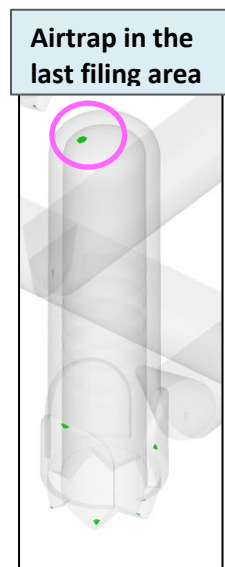
- Critical airtrap noticed in the last filling area in the cavity side at the top of the plunger
- Flow hesitation noticed and temperature drop(temperature of the molten material) & pressure drop also observed
- Airtraps formed in the core side can be always easily relieved with core pins, but airtrap in the cavity side is tough to eliminate without venting

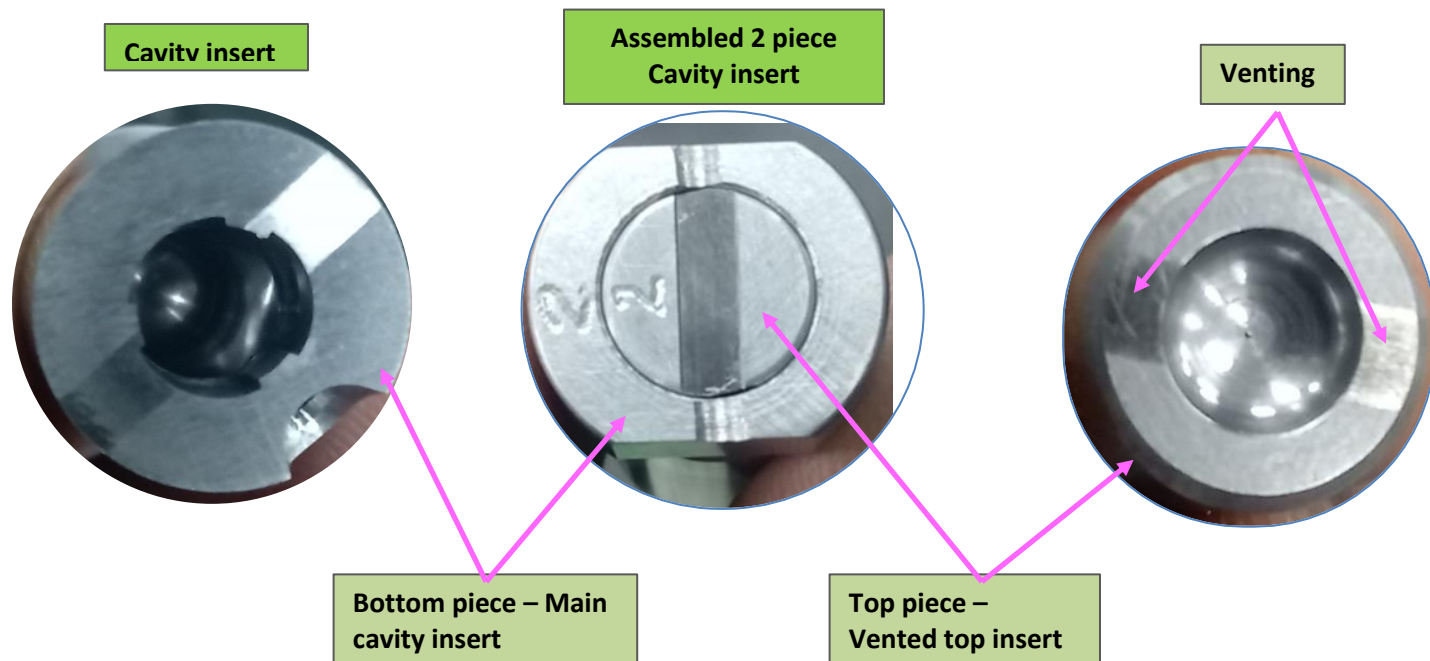
Modified cavity inserts after adding venting slots

- The tool maker had made the corrections in the tool and tool trial was carried out
- Few key Process parameters were suggested to the tool maker based on the Moldflow simulation results
- Initially higher injection time was used by the tool maker, later it was reduced to 1.0s for better filling behavior
- After tool modification, the filling results were great and we have achieved 100% filling. The hole formed earlier doesn't exist anymore

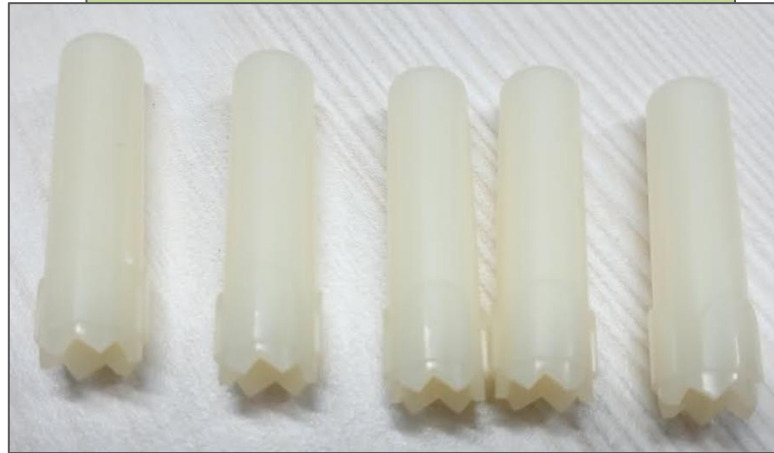
- The tool maker had made the corrections in the tool in all the 64 cavities
- Successfully all 64 cavities filled completely.
- Few of the cavities showed some **visible weld marks and flow marks** which is a surface defect
- The weld marks were visible and deep
- These weld marks affects the product quality aesthetically
- And also there were few flow marks in few of the cavities

Successful molding after tool
modification – 100%filled samples

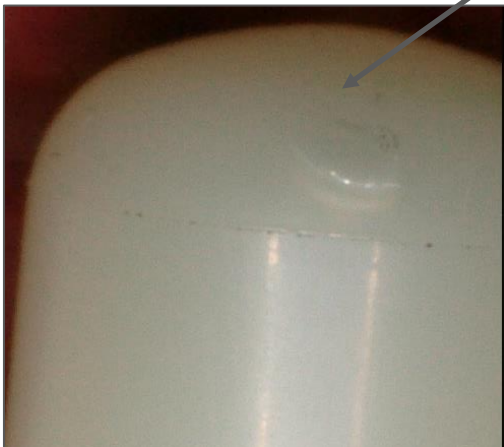
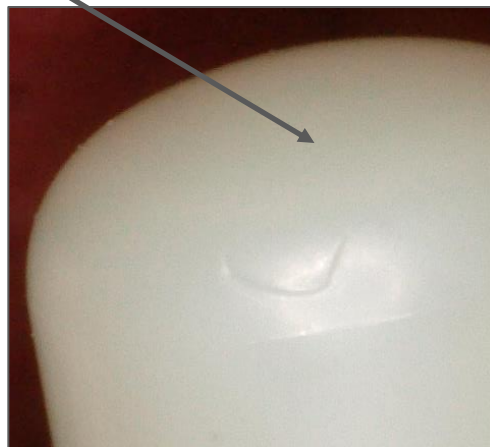
Weldmarks in the samples :

Deep visible weld marks

- To avoid the weld marks, it was recommended to increase the venting land to avoid visible weld marks
- As per the suggestion, the tool maker had widened the venting land area.
- Venting land area was increased
- Additionally venting was provided on four sides
- Trial has been conducted with this modified venting.
- Current samples looks free from visible weldmarks

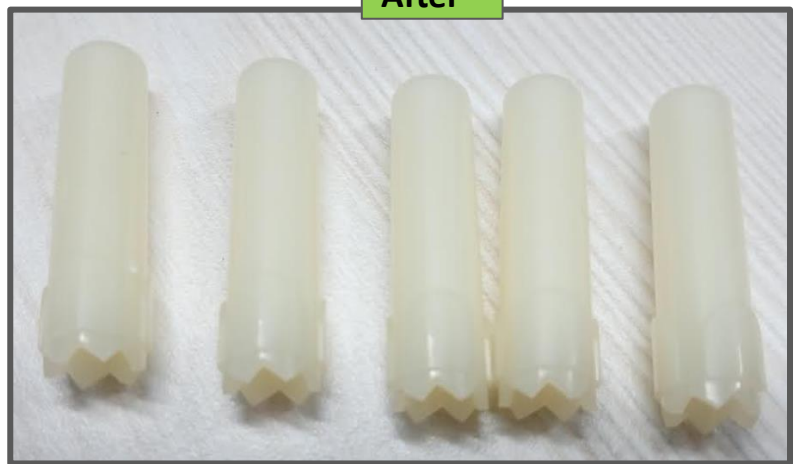
After

- The molded components are defect free now
