Laser Scanning During Construction: Five Case Studies Demonstrating Practical Use

Danielle O'Connell and Evan Reilly

Skanska Innovative Construction Solutions

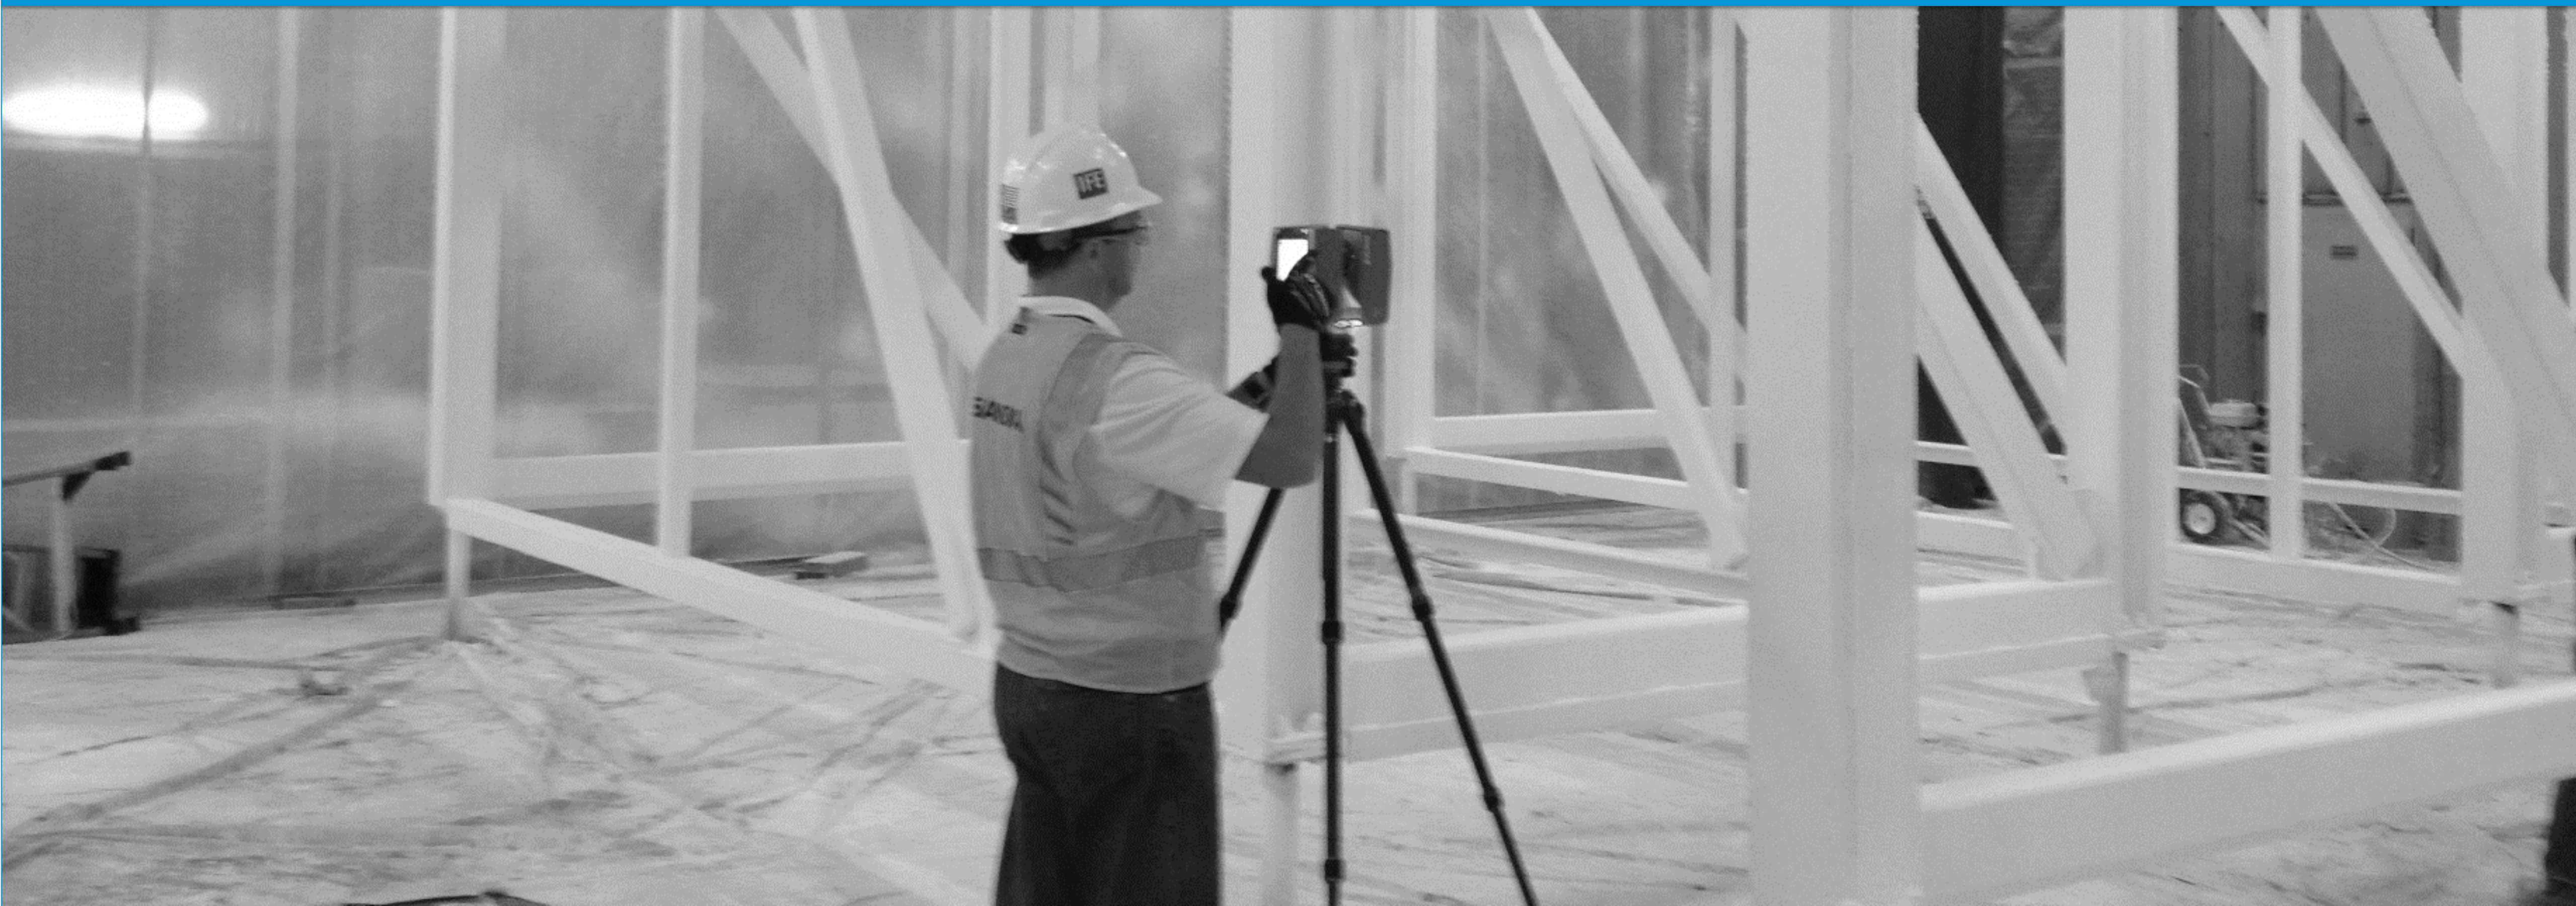
Laser Scanning Uses

Rapid Data Collection

- Millions of measurements in a short period of time
- High/hard to reach spaces, no ladder required

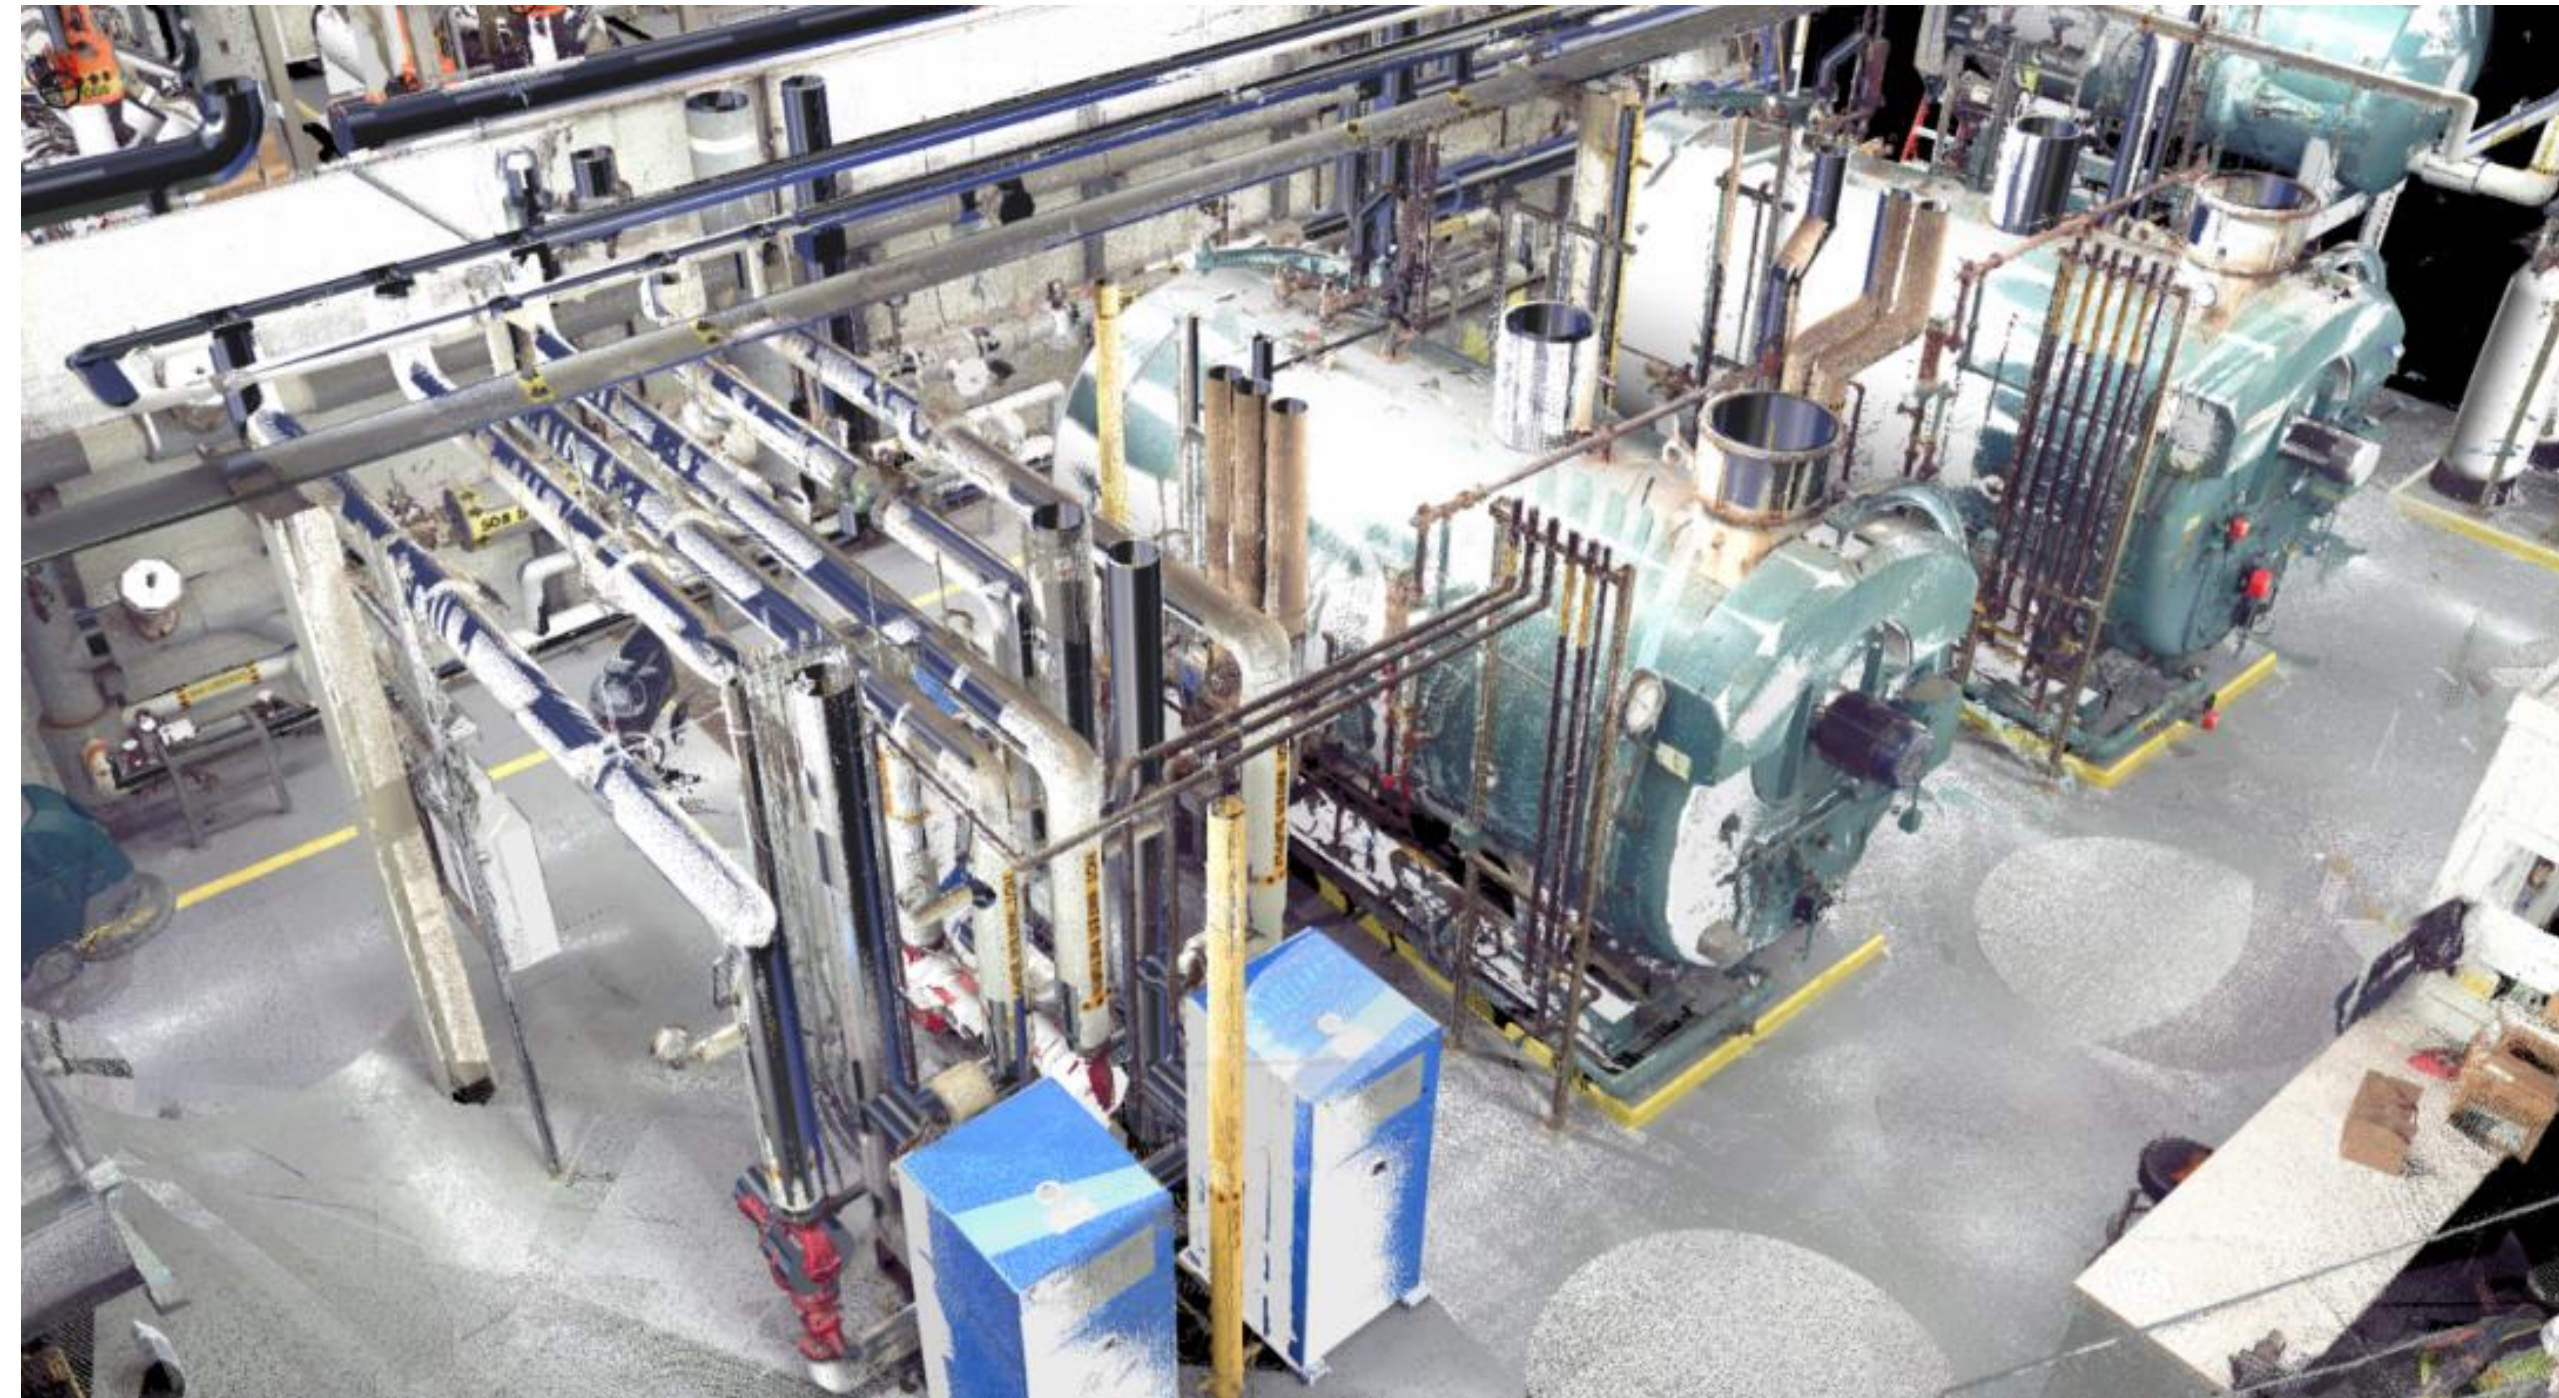
Existing Conditions Verification

- Provides accurate measurements of structure, MEP, etc., increasing predictability in the field

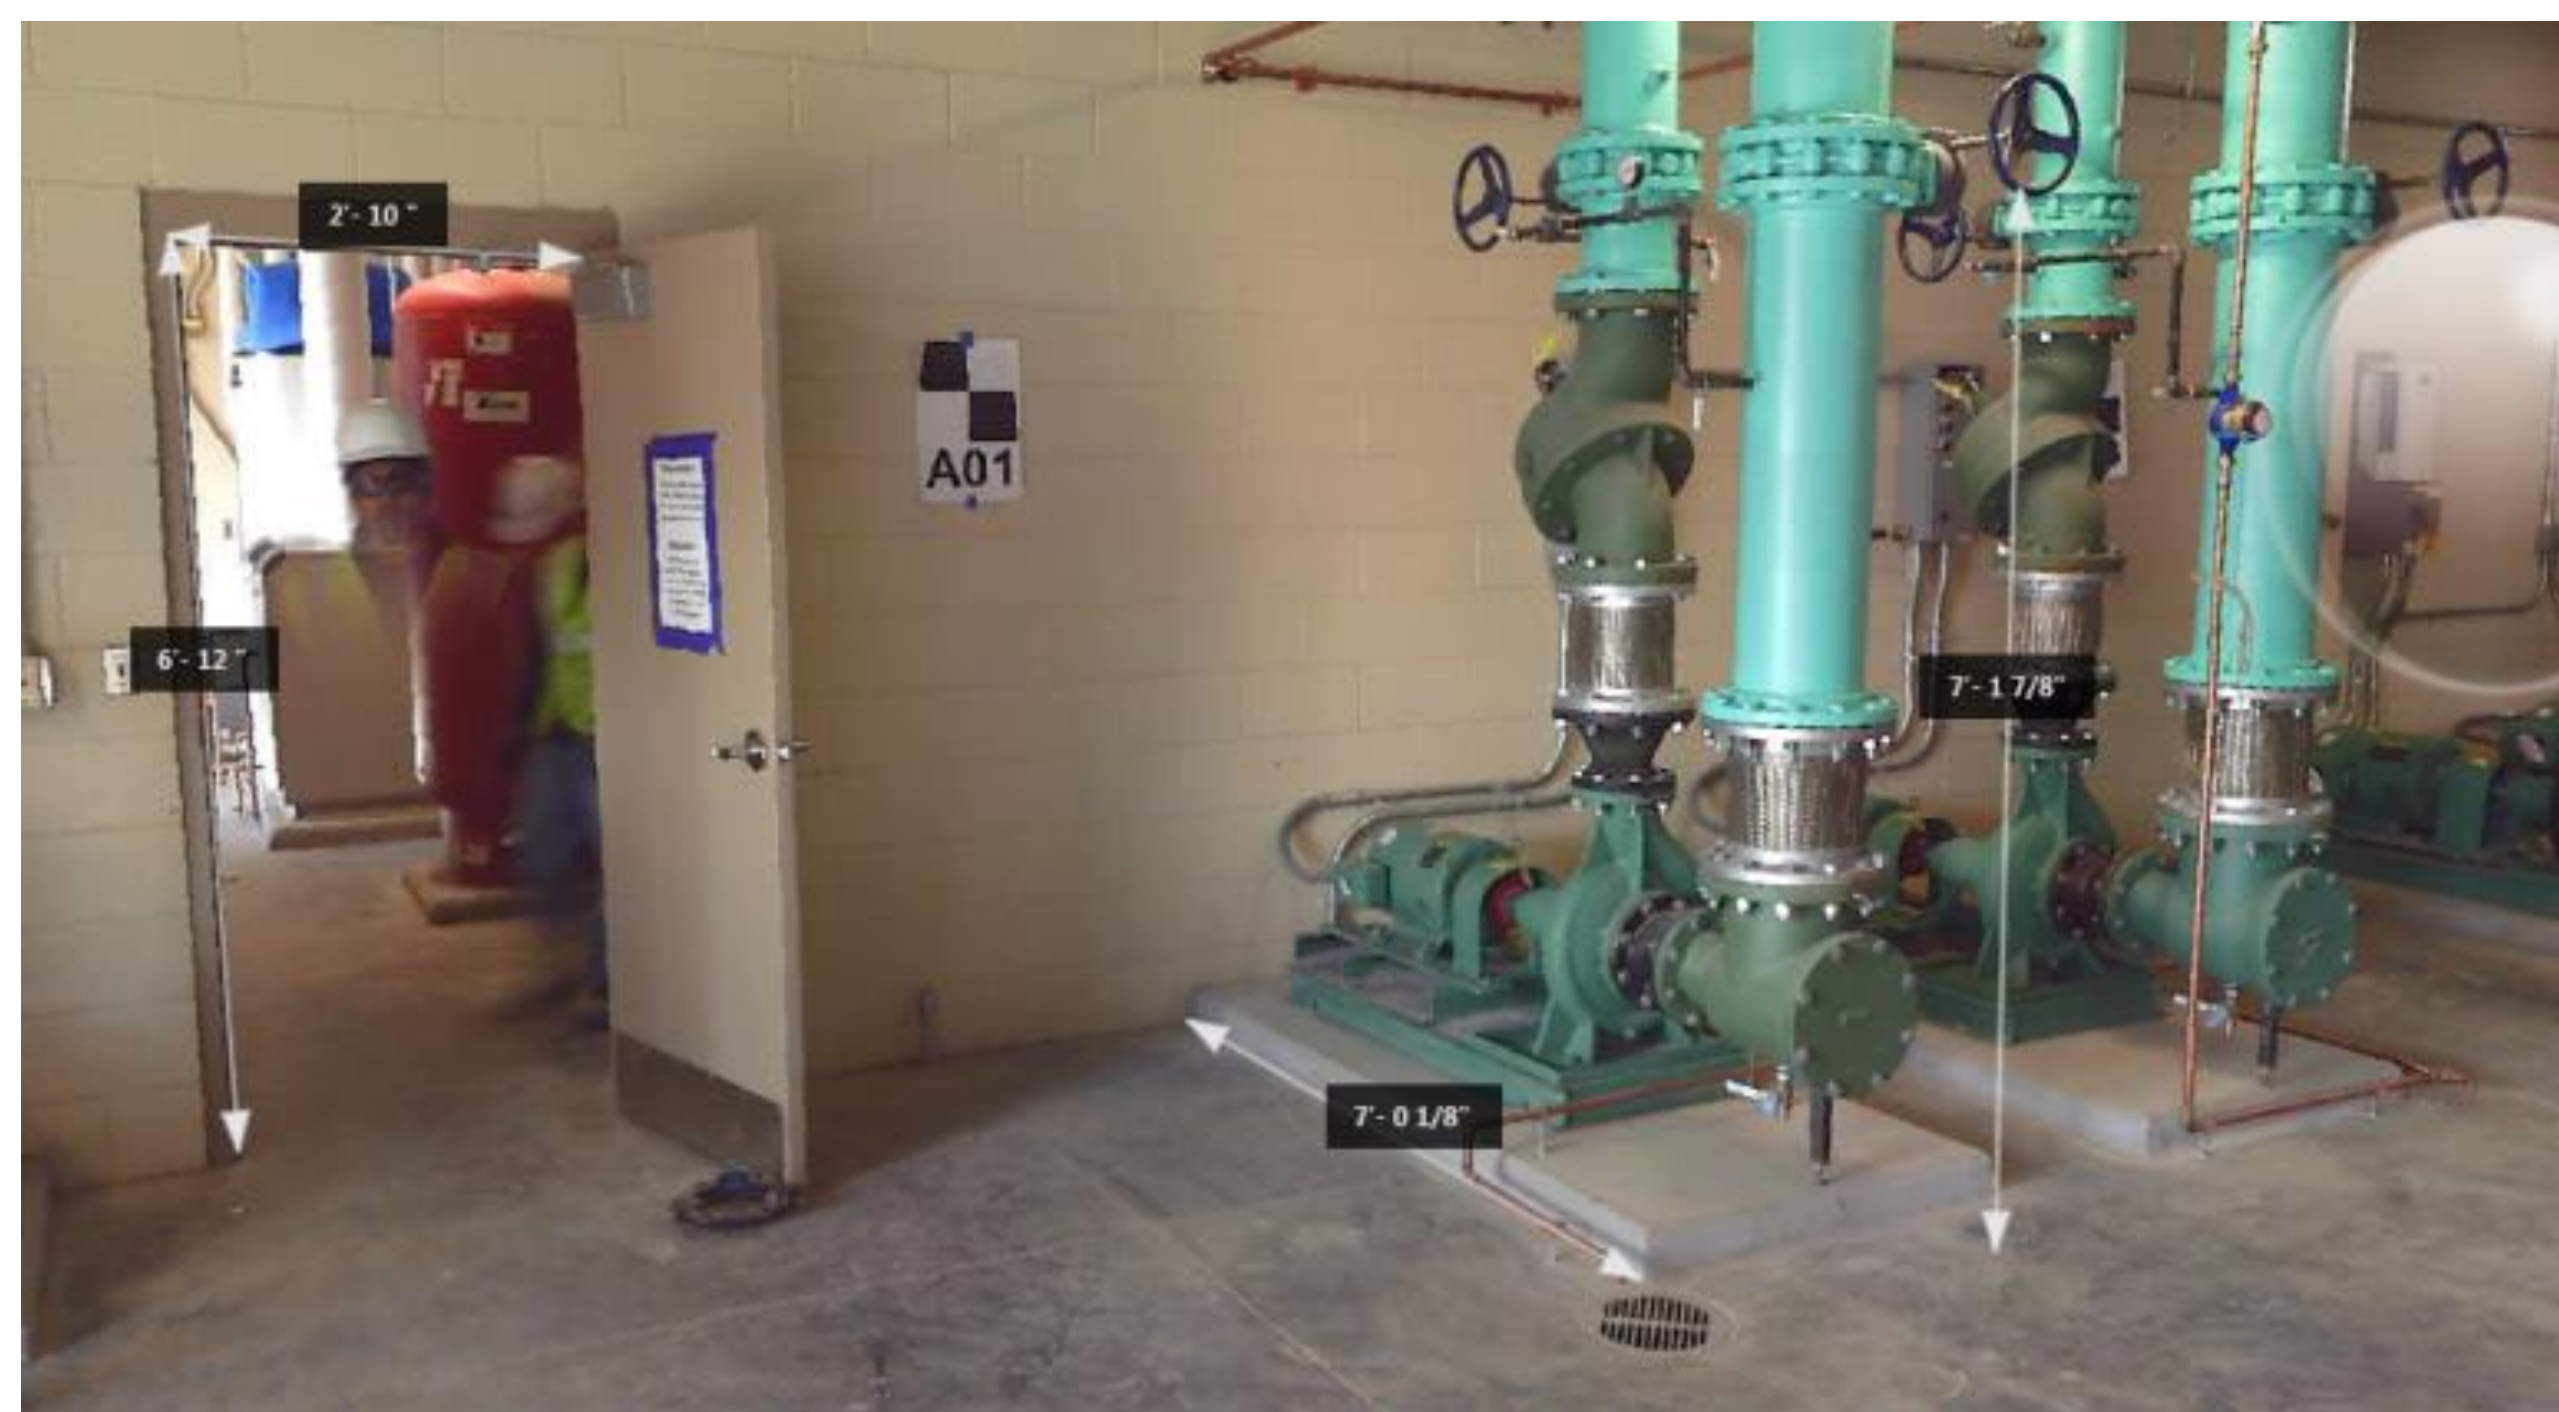
Accurate As-built Conditions

- Accurate verification of systems or for turnover and asset management
- Systems tolerances (i.e., steel and concrete) can be collected and verified.

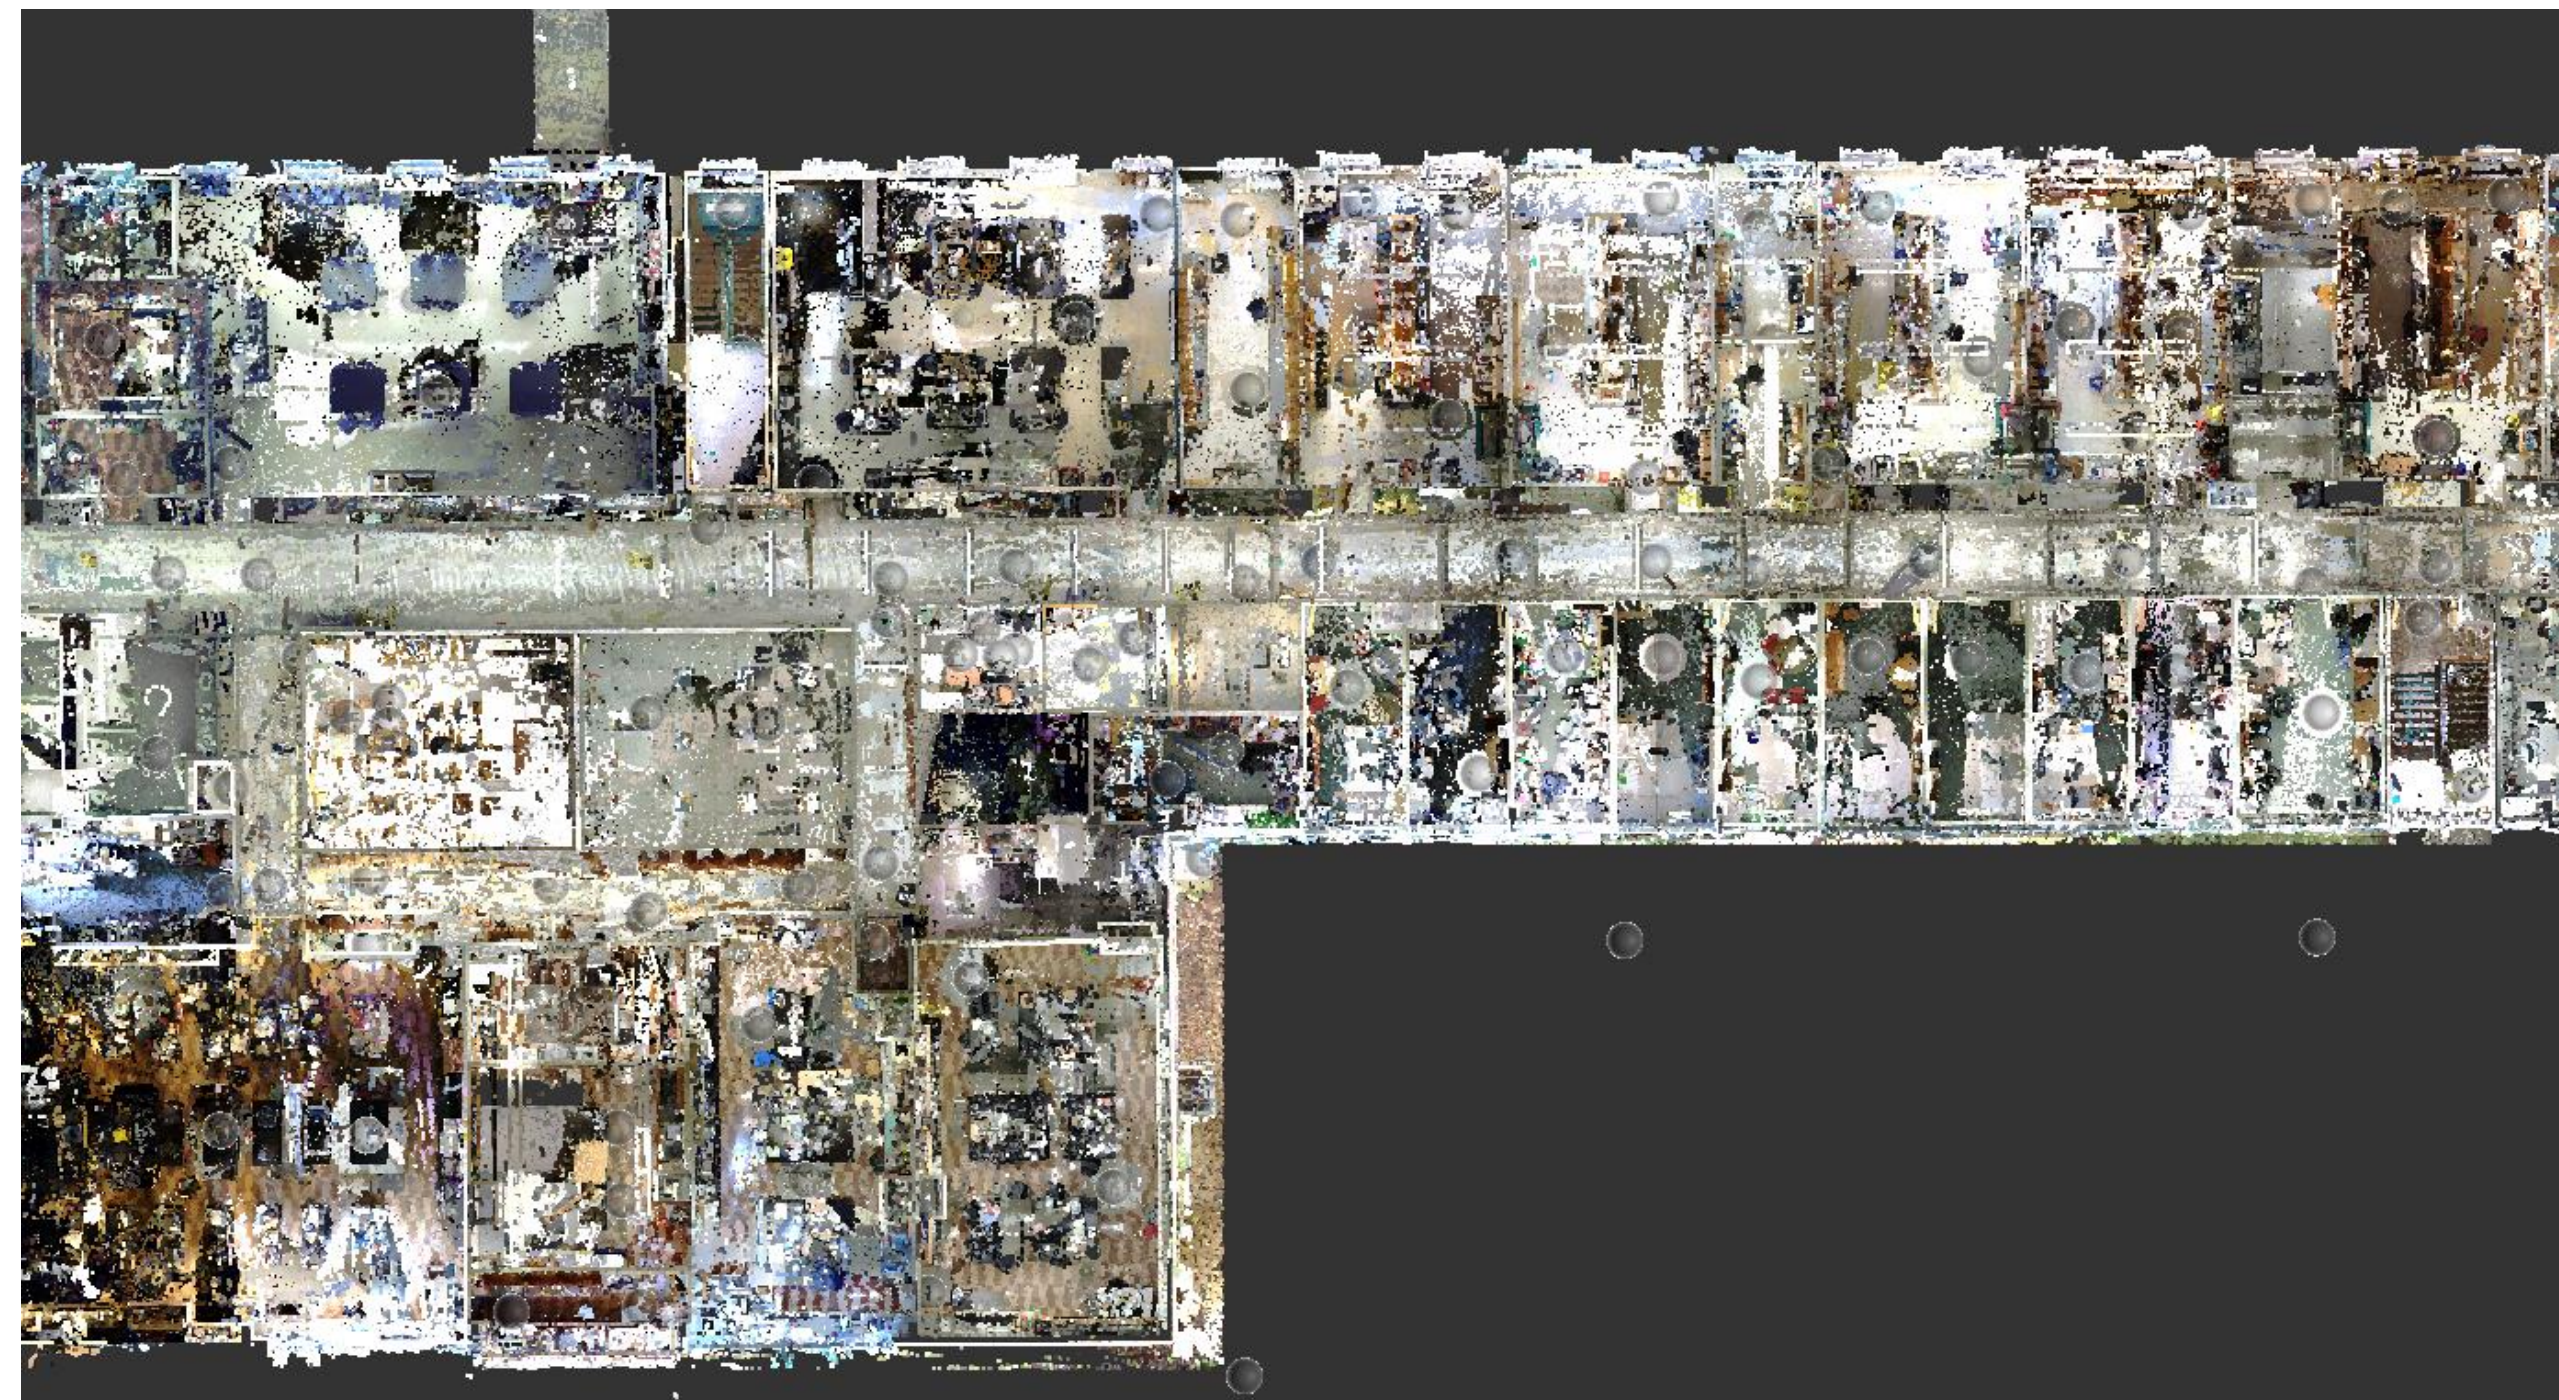
Building Floor Plans

- Design team used the point cloud to create level-by-level plans of the existing conditions.

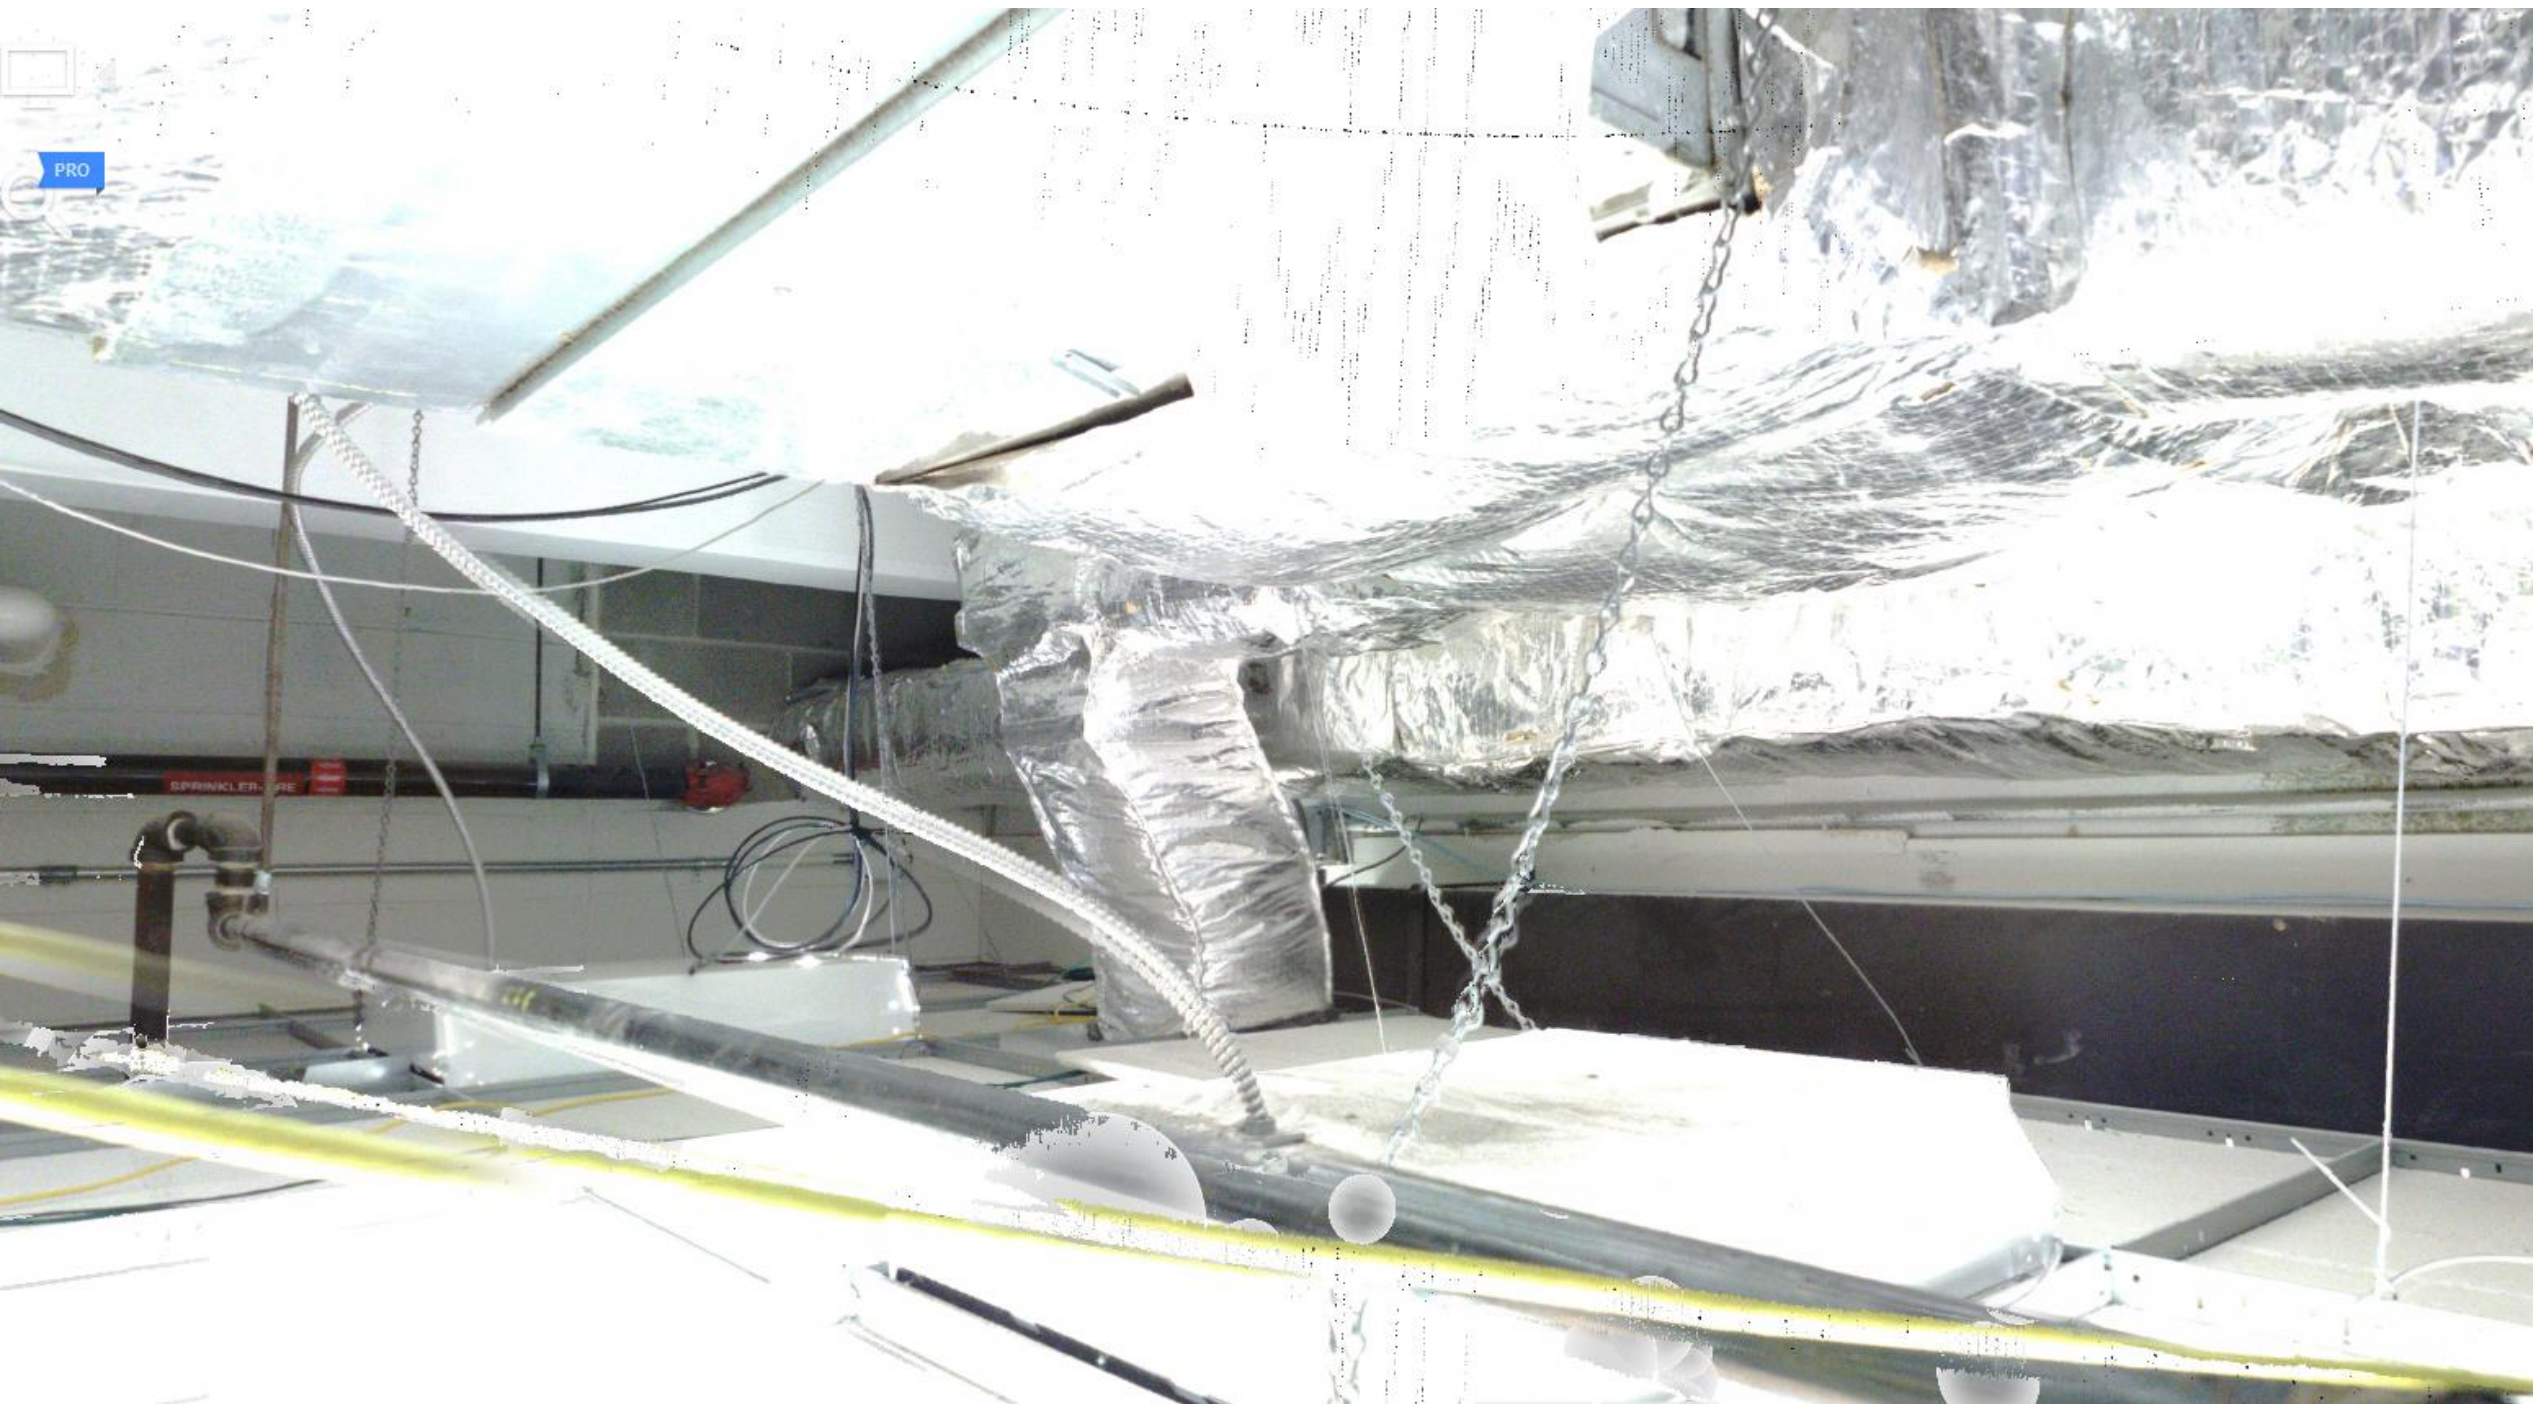
Above Ceiling Conditions

- Scanner was placed above all drop ceilings to capture existing MEP/FP systems, which were then documented by the engineering team.

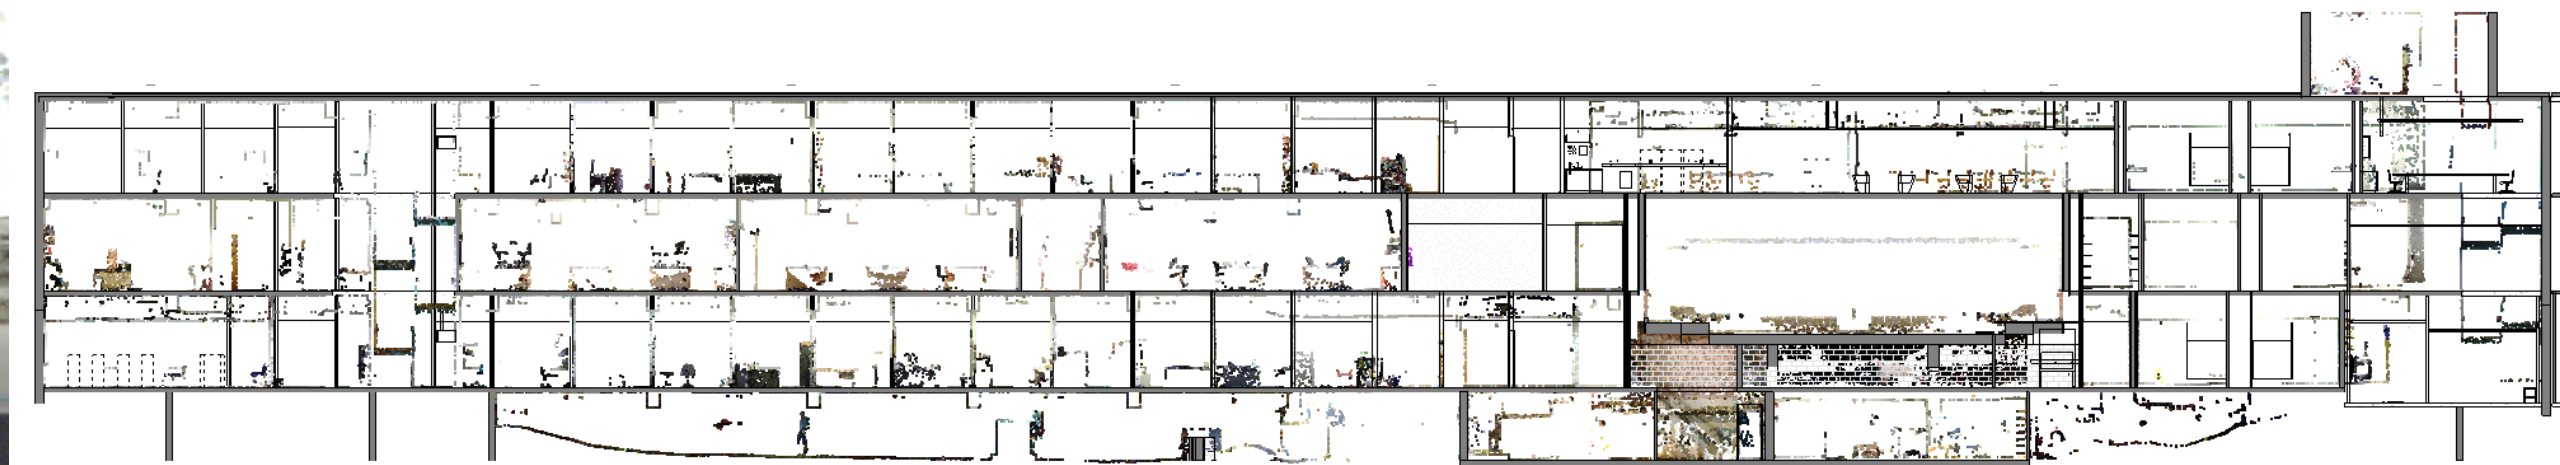
Building Sections

- Building sections were cut through a model and point cloud overlay to easily identify slopes of existing floors in various locations throughout the building.

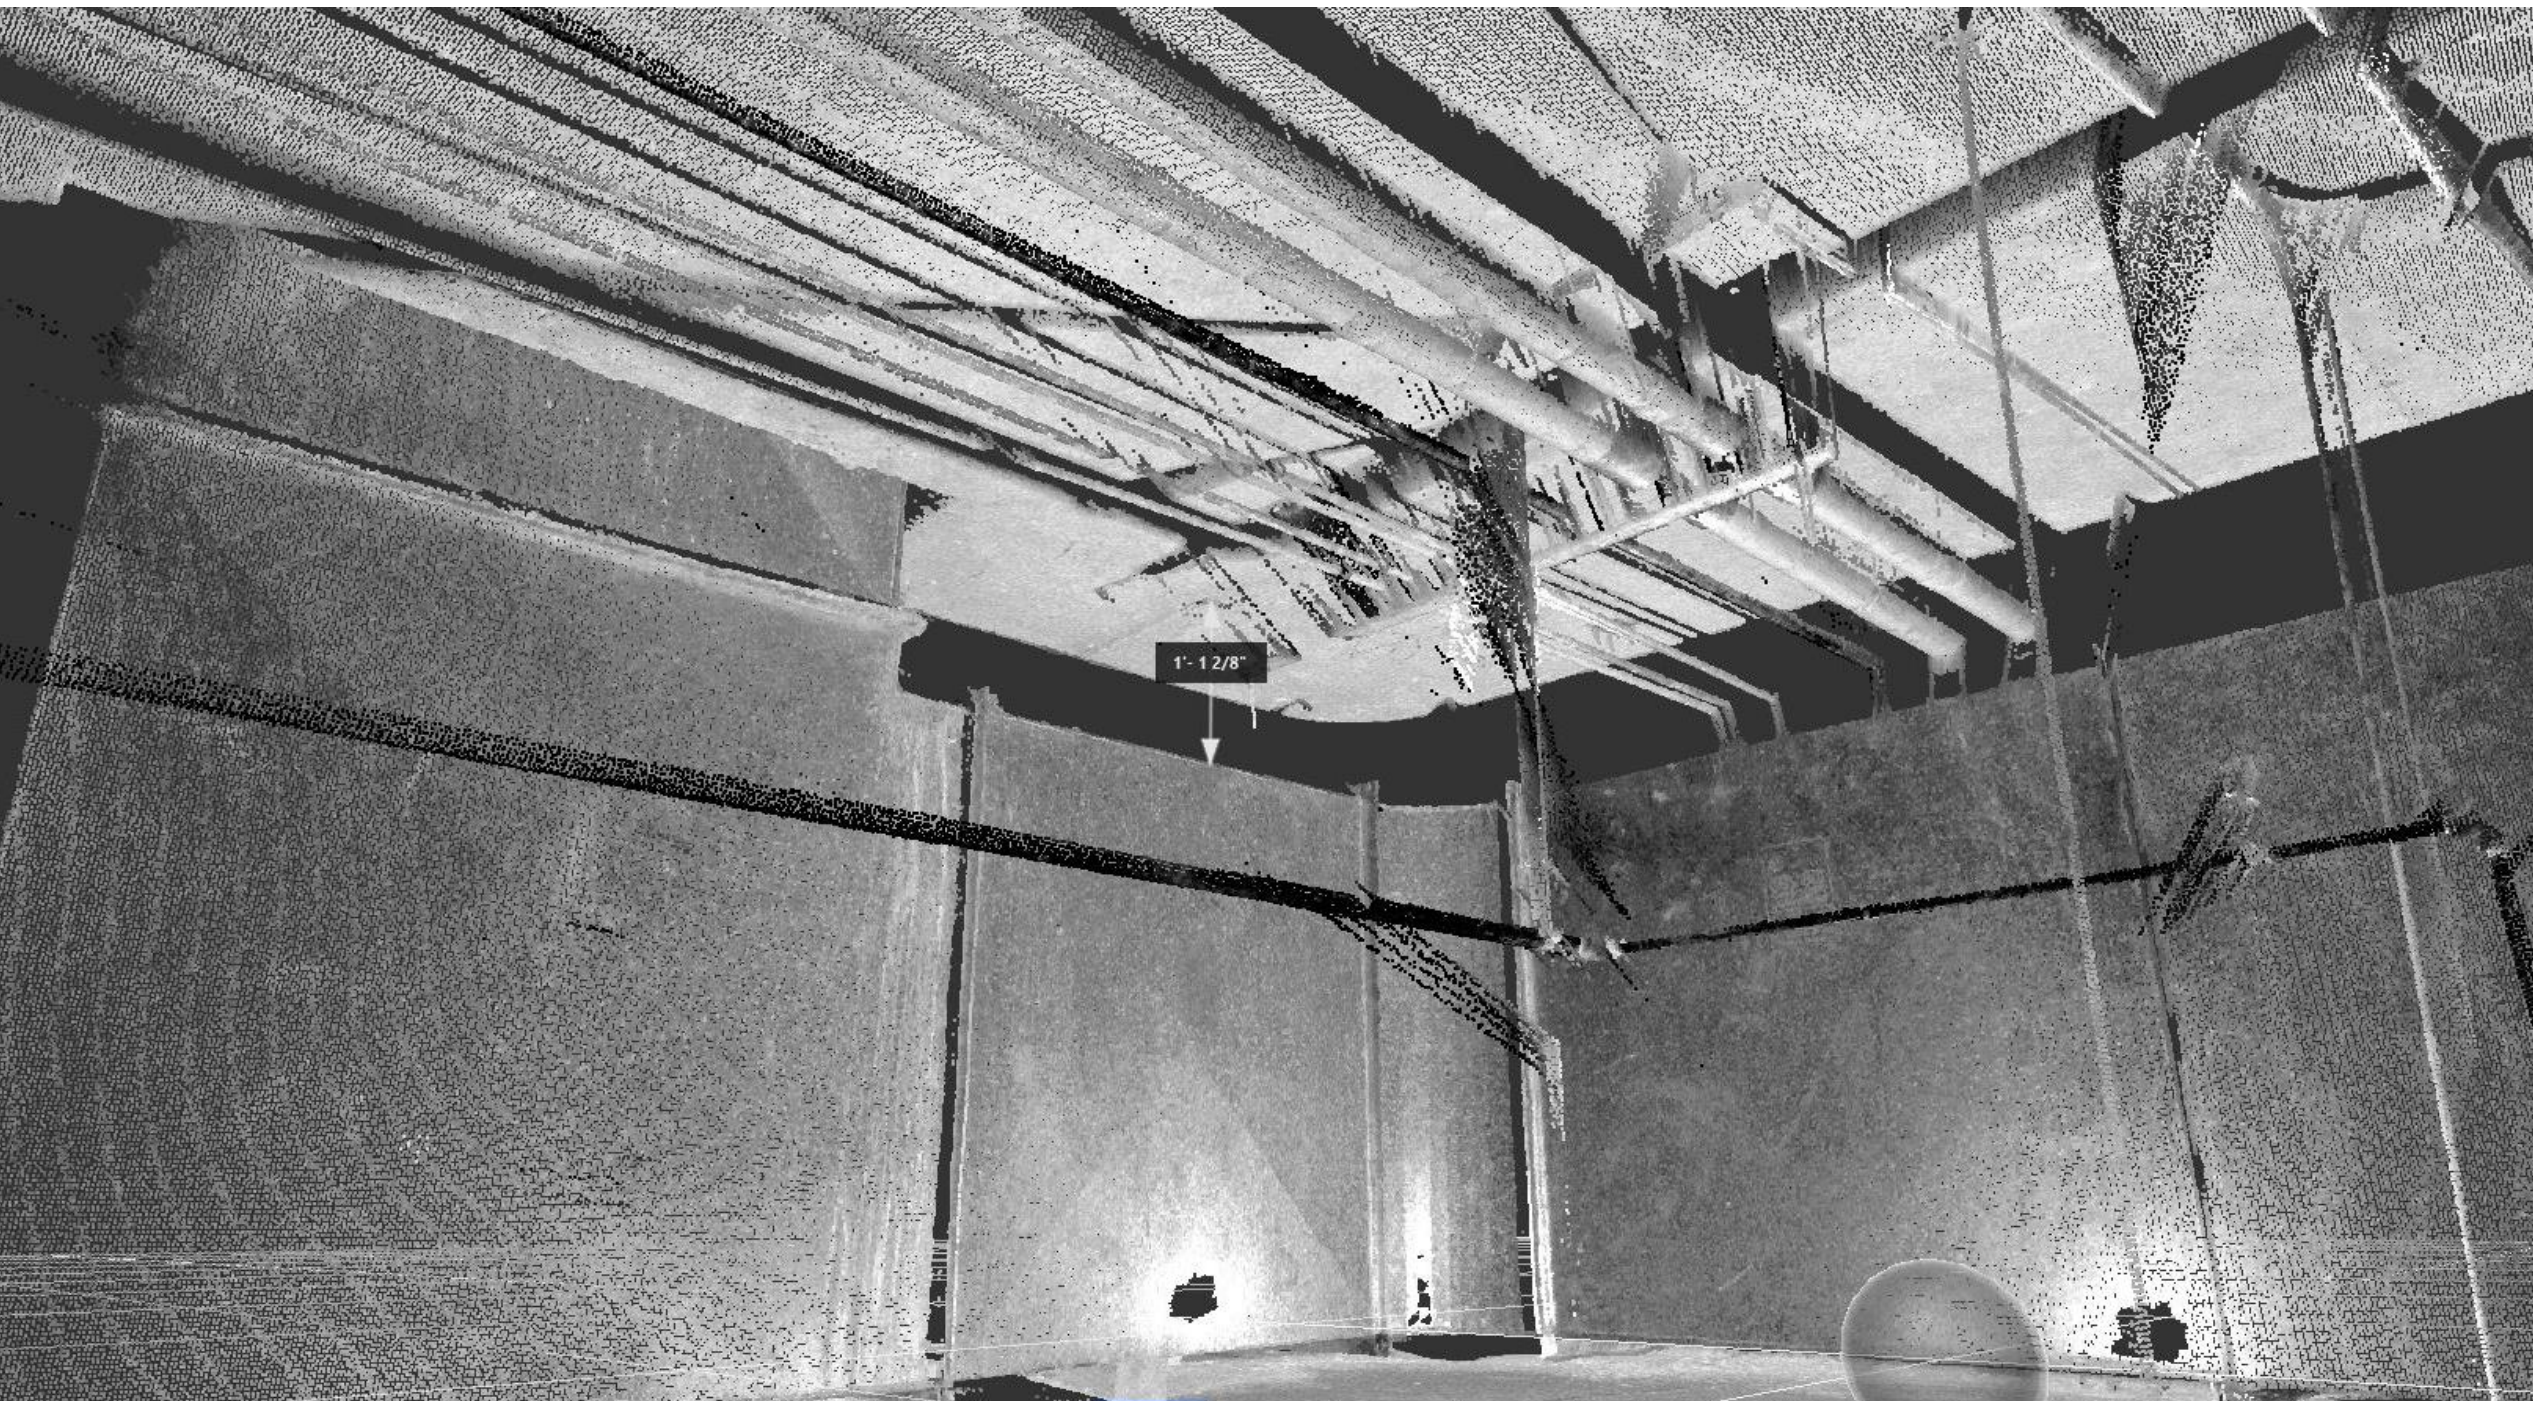
Above-Ceiling Investigation

- Collected laser scan data for coordination of proposed re-route of new electrical conduits
- Identified 13" void between top of existing duct and bottom of concrete slab to run 12 new 4" conduit, when design showed 5" gap
