Importance of Venting in Injection Molding

Pandiarajaguru

Newell Brands

Example of Venting issue :

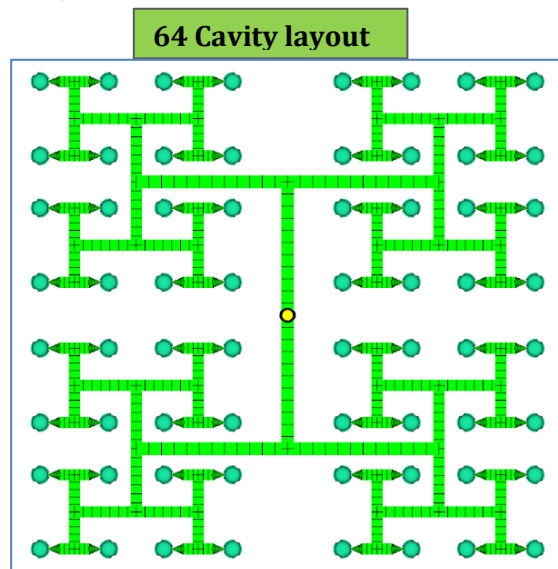
- Multicavity mold for making component of Pen
- 64 cavity tool
- Balanced layout

- Difficulties in molding the parts due to airtrap
- Short filling is noticed in all 64 cavities
- A hole is formed at the top of the plunger due to airtrap which aesthetically affects the quality and makes this component unusable
- On looking the samples closer, there were flow marks too
- Short fill noticed in all the 64 cavities are at the same place

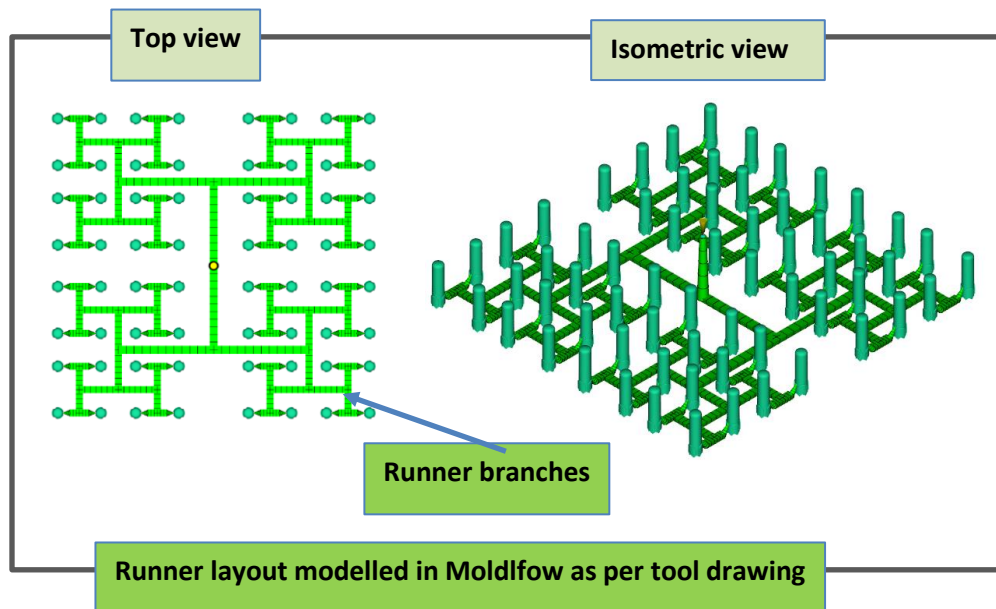
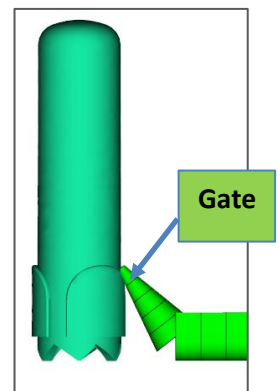
- Full mold drawing was obtained from the tool maker
- Moldflow software was used for replicating the molding scenario.
- Full mold set up is modelled in Moldflow simulation. 64 cavities were modelled along with the gate/ runner set up
- Multicavity flow simulation was carried out.

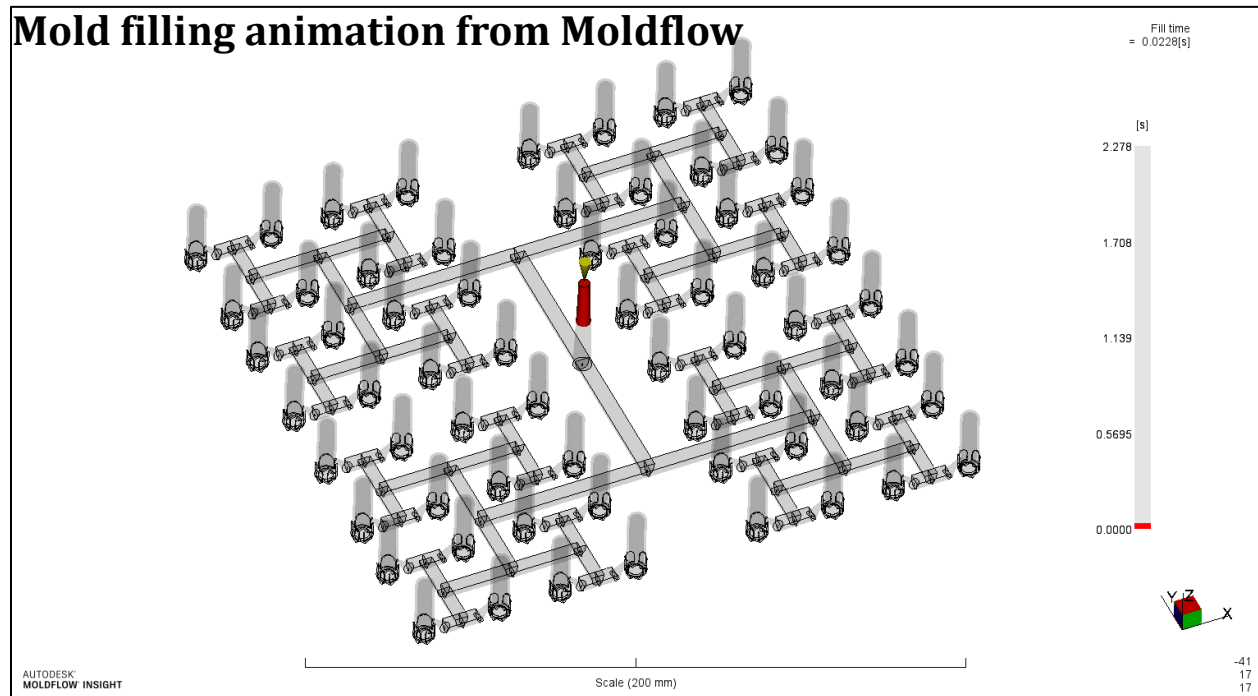
Filling pattern and Airtrap

- Critical airtrap noticed in the last filling area in the cavity side at the top of the plunger
- Flow hesitation noticed and temperature drop(temperature of the molten material) & pressure drop also observed
- Airtraps formed in the core side can be always easily relieved with core pins, but airtrap in the cavity side is tough to eliminate without venting

- To relieve the air trap or gas trap, it was recommended to provide venting at the top of the plunger where the hole is formed
- Cavity was split into two pieces. Two piece cavity insert concept used.
- Gas vent clearance to be provided in the tool
